# RESEARCH ON FAILURE AND COLLAPSE OF BUILDINGS IN KENYA

Published by:
National Construction Authority,
9th Floor, KCB Towers
P. O. Box 21046 - 00100, Nairobi, Kenya
Telephone: +254-709 126 102/172/173
E-mail: info@nca.go.ke
http://www.nca.go.ke

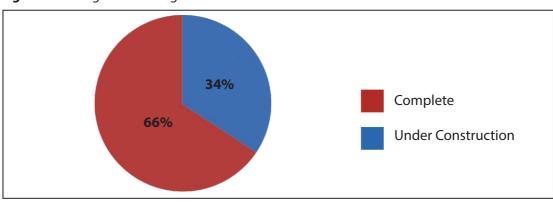
Figure 6.5: Stages of Building Failure

From the Figure 7.4 it can be observed that out of the 87 documented cases contained in 66% of the buildings collapsed after completion of works while 34% of the buildings collapsed while still under construction.

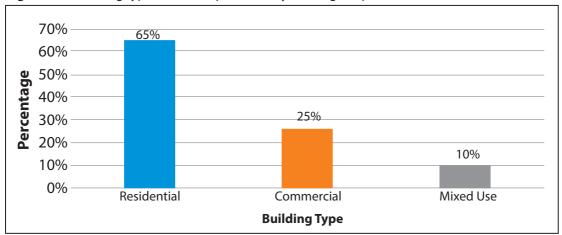
**Figure 6.5:** Building types that collapsed in Kenya during the period 2016-2019

As shown in Figure 7.3, majority of buildings that collapsed were residential in nature. This is attributable to the high demand of residential buildings. 25% of the collapses were commercial, while 10% were not of mixed use. Mixed use included both commercial and residential sections within the divided units.

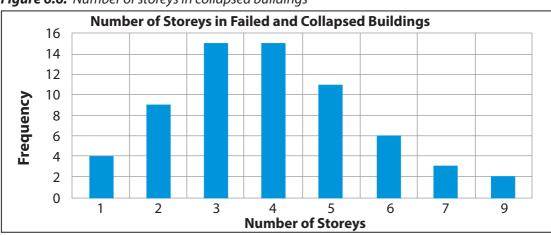
**Figure 6.6:** Number of storeys in collapsed buildings

The figure below shows frequency of collapse of the storey-buildings. From data contained in Appendix 1, it is evident that 84% of structures that collapsed are buildings, with the rest of collapses (16%) being boundary walls.

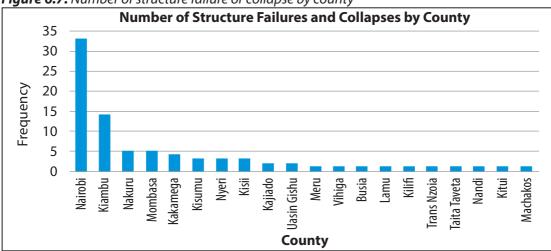
Figure 6.7: Number of structure failure or collapse by county

From fig. 7.5, the study established that building collapses are predominantly found in cities and peri-urban counties. Nairobi leads with 33 cases, followed by Kiambu with 14 cases while Nakuru and Mombasa each having 5 cases. This can be attributed to the high demand of residential and commercial buildings in the major towns.

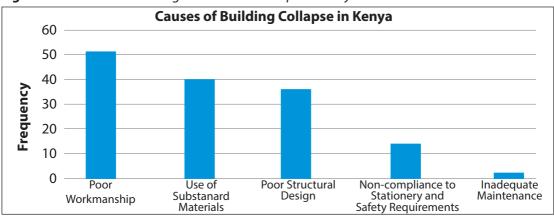
**Figure 6.9:** Causes of Building Failures and Collapse in Kenya

The analysis of the various causes of buildings collapse is shown in Figure 7.7. Poor workmanship is the main cause with 51 (35%) cases observed, substandard materials with 40 (28%) cases observed, poor structural design with 36 (25%) cases, non-compliance with statutory and safety requirements with 13 (9%) cases and inadequate maintenance with 2 (3%). These causes are discussed in detailed in the preceding sections.

From the Table 7.4, the causes of building failure are classified into the following; poor workmanship; substandard materials; non-compliance with building standards and regulations (safety requirements, materials, mix-ratios, approvals); inadequate structural design, overloading of the structure and inadequate maintenance.
